Bella Masonry & Construction 5 Spring street North Brookfield, Ma 01535 bellamasonryandconstruction@gmail.com (508) 889 7012

Foundation Inspection Report

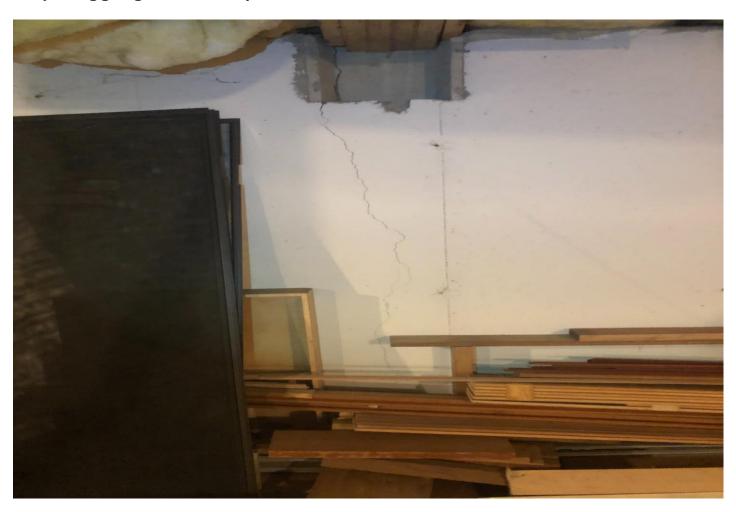
Structural Foundation issue #1, in location of main point loaded caring beam on the ((D) Delta side) facing garage and driveway.

Complication: a structural crack is in the main location of the beam that supports the homes main span from (D delta) side to (B bravo) side and everything in its entirety between the foundation, above the beam. There is a compound crack in this location that starts from top of the foundation and fully travels to the bottom of the foundation. At this time, it should also be noted that the main beam does not sit into its designed engineered foundation pocket, instead the microlaminated beams sit on top of the foundation above of the pocket. With a compound crack in the location of the point loaded beam can cause adverse effects on the home's footing, foundation, also the homes structural integrity above this beam. **It should also be noted that the home is not in imminent danger of collapse and or foundation failure at this time.**

Recommendation: grind and prepare the crack surface approximately 8" beyond the entire crack bilaterally to remove paint and loose and/or any foreign martial. Remove sand, dirt and organic material by process of forced pressurized air infiltration into the cracks (midpoint) or core to allow for maximum saturant adhesion and bonding. Measure and layout for Rhino® cracklock® carbon fiber foundation ties, approximately 16" on center. Drill holes for the Rhino® cracklock® ties approximately 2" into the face of the concrete foundation. Saw cut into the concrete foundation with a line connected to the two drill marks aproximally 1½" deep. Use Sika® high strength anchoring epoxy to install the Rhino® cracklock® ties on the recommended lay-out. Set structural injection ports on the crack from bottom to top approximately every 6-10" with Sika® high strength anchoring epoxy. Seal the rest of the crack with Sika® high grade anchoring epoxy. Inject Rhino® high grade structural resin saturant into the crack through the installed injection ports, starting at the bottom of the wall crack until resin starts flowing out of the to the next port above the port being injected, repeat this process until resin flows from the top of the foundation with 100% of voids and crack incased in structural resin. Let the foundation cure and saturate for 1-3 days depending on humidity. Re-grind the surface of the crack bilaterally to remove ports and Sika® high strength anchoring epoxy until the foundation is smooth again. install Rhino® carbon fiber lamination saturant to the prepared area from top to bottom to saturate and bond to the concrete. Install Rhino® carbon fiber matting from the top of the crack to the bottom of the crack and laminate to the floor in the location of the crack.

At a later date, as an aggressive option we would recommend a licensed experienced structural carpenter under the direction of the building official with a permit, to install blocking into the existing main beam pockets to help support and disburse the weight the point loaded beam. We would also recommend installing a lally column approximately 6-8" of the wall with a 1x1x1' concrete footing to further disburse the weight.

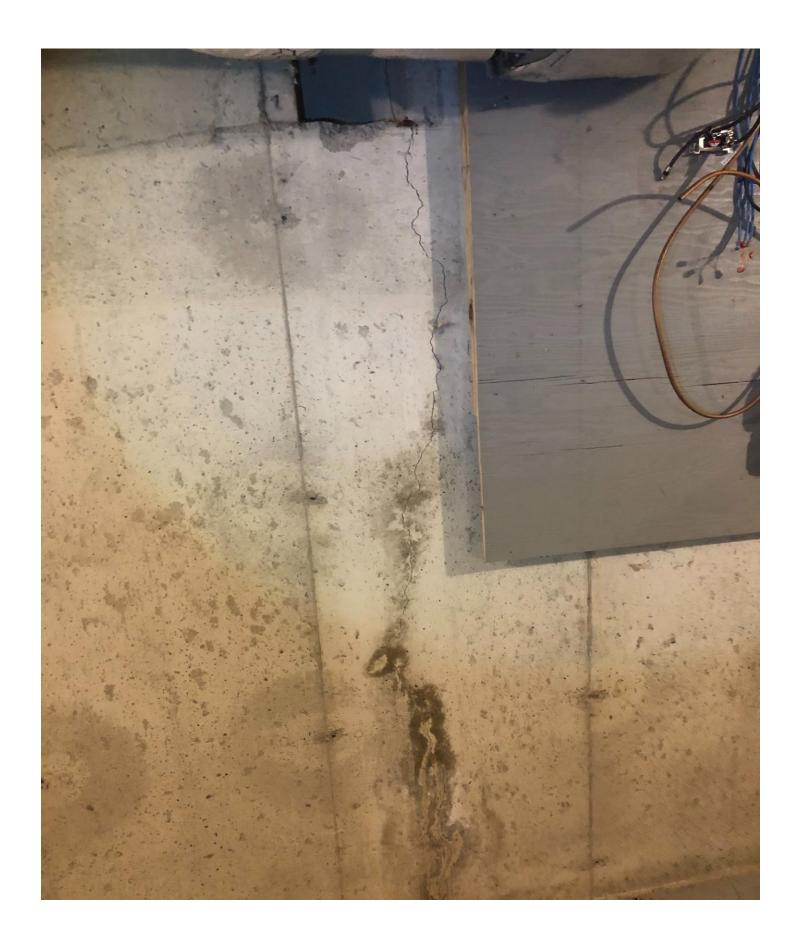
Structural Foundation issue #2, in location of main point loaded caring beam on the ((B) Bravo side) facing the side yard

Complication: a structural crack is in the main location of the point loaded beam that supports the homes main span from (B bravo) side to (D delta) side and everything in its entirety above the beam between the foundation. There is a compound crack in this location that starts from top of the foundation and fully travels to the bottom of the foundation this crack shows evidence of water infiltration into the home. At this time, it should also be noted that the main beam does not sit into its designed engineered foundation pocket, instead the microlaminated beam sits on top of the foundation above the pocket! With a compound crack in the location of the point loaded beam can cause adverse effects on the home's footing, foundation, also the homes structural integrity above this beam. **It should also be noted that the home is not in imminent danger of collapse and or foundation failure at this time.**

Recommendation: as the electrical plywood panel is in the way of the repair, a licensed electrician to move the plywood panel and the reinstall once work is completed if and as needed, grind and prepare the crack surface approximately 8" beyond the entire crack bilaterally to remove paint and loose and/or any foreign martial. Remove sand, dirt and organic material by process of forced pressurized air infiltration into the cracks (midpoint) or core to allow for maximum saturant adhesion and bonding. Measure and layout for Rhino® cracklock® carbon fiber foundation ties, approximately 16" on center. Drill holes for the Rhino® cracklock® ties approximately 2" into the face of the concrete foundation. Saw cut into the concrete foundation a line connected to the two drill marks approximately 1½"deep. Use Sika® high strength anchoring epoxy to install the Rhino® cracklock® ties on the recommended lay-out. Set structural resin injection ports on the crack from bottom to top approximately every 6-10" with Sika® high strength anchoring epoxy. Seal the rest of the crack with Sika® high grade anchoring epoxy. Inject Rhino ®high grade structural resin saturant into the install resin injection ports starting at the bottom of the wall crack until resin starts flowing out of the to the next injection port above the port being injected, repeat this process until resin flows from the top of the foundation with 100% of voids and crack incased in structural resin. Let the foundation cure and saturate for 1-3 days depending on humidity. Regrind the surface of the crack bilaterally to remove ports and sika® high strength anchoring epoxy until the foundation is smooth again, install Rhino® carbon fiber lamination saturant to the prepared area from top to bottom to laminate and bond to the concrete. Install Rhino® carbon fiber matting from the top of the crack to the bottom of the crack and laminate to the floor in the location of the crack.

At a later date, as an aggressive option we would recommend a licensed structural carpenter under the direction of the building official with a permit to Install blocking into the existing main beam pockets to help support and disburse the weight the point loaded beam. We would also recombed installing a lally column approximately 6-8 with a $1\times1\times1$ concrete footing of the wall to further disburse the weight.

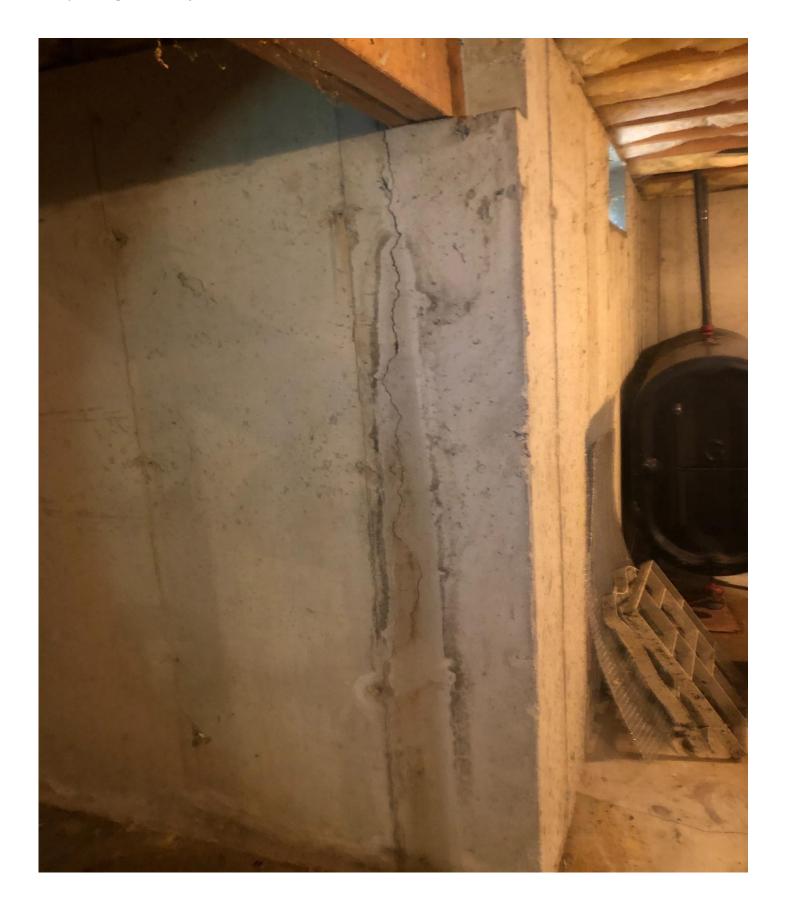
Structural Foundation issue #3 in location of main point loaded caring beam on the ((C) Charlie side) facing the backyard

Complication: a structural crack is in the location of the beam that supports the homes entrance off the kitchen to the sunroom span from ((C)Charlie) and everything in its entirety between the foundation cove and point loaded above. This crack is a major concern as this is aproximally ¼" and has shown that it has moved out of the plane with signs of soil and water erosion and soil and water infiltration to the home. The cracks location is on the foundation corner, with no foundation support to the right of foundation into the center of the home this foundation crack is of immediate concern! This is a compound crack with compound lateral cracks in this location. The crack starts from top of the foundation and fully travels to the bottom of the foundation. At this time, it should also be noted that this beam does sit into its designed engineered foundation pocket, instead of the other TWO the microlaminated beams sit on top of the foundation on top of the pocket. However, it should also be noted that this beam is starting to migrate inward to the home's interior. With a compound crack in the location of a corner and also at the location of point loaded beam can cause adverse effects on the home's footing, foundation, also the homes structural integrity above this beam. It should also be noted that the home is not in imminent danger of collapse and or foundation failure at this time. **** you may want to have this crack evaluated by a structural engineer as a second opinion***

Recommendation: grind and prepare the crack surface approximately 8" beyond the entire crack bilaterally, also starting at the bottom of the foundation grind on a layout of 24" horizontally in about 6" x 4'on each side of the corner on center to remove paint and loose and/or any foreign martial. Remove sand, dirt and organic material by process of forced pressurized air infiltration into the cracks (midpoint) or core to allow for maximum saturant adhesion and bonding. Measure and layout for Rhino® cracklock® carbon fiber foundation ties, approximately 16" on center. Drill holes for the Rhino® cracklock® ties approximately 2" into the face of the concrete foundation. Saw cut into the concrete foundation and connect the two drill marks aproximally 1½" deep. Use sika® high strength anchoring epoxy to install the Rhino® cracklock® ties on the recommended lay-out. Set structural resin injection ports on the crack from bottom to top approximately every 6-10" with Sika® high strength anchoring epoxy. Seal the rest of the crack with Sika® high grade anchoring epoxy. Inject Rhino ®high grade structural resin saturant into the crack starting at the bottom injection port until resin starts flowing out of the to the next port above the injection port being injected, repeat this process until resin flows from the top of the foundation with 100% of voids and crack incased in structural resin. Let the foundation cure and saturate for 1-3 days depending on humidity. Regrind the surface of the crack bilaterally to remove ports and Rhino® high strength anchoring epoxy until the foundation is smooth again, install Rhino® carbon fiber lamination saturant to the prepared area and the proposed horizontal layout from top to bottom to adhere and bond to the concrete. Install Rhino® carbon fiber matting from the top of the crack to the bottom of the crack and laminate to the floor in the location of the crack. Then install horizontal Rhino® 4' carbon fiber straps from the floor to the top of the foundation in 24" on center layout or until the foundation top is reached.

along with the above repair, we would recommend strongly recommend a experienced licensed structural carpenter under the direction of the building official with a permit to Install blocking into the existing beam pocket to stop the beam from migrating out of plum/plane any further, this could also be achieved from using Simpson® engineered metal connectors. This will also help disburse the weight the point loaded beam. We would also recombed installing a lally column approximately 6-8" of the wall with a 1x1x1' concrete footing to further disburse the weight in the location of this crack.
